Application for Financial Assistance (Historic Buildings Grants) from the Conservation and Heritage Fund for The Beehive, Main Road, Betley (Ref: 18/19004/HBG).

- 1. £5,000 Historic Building Grant to repair two gables on a timber framed cottage, including propping, new timber framing with joints/pegs, replacement brick infills with lime mortar, making good the internal walls, subject to the appropriate standard conditions**

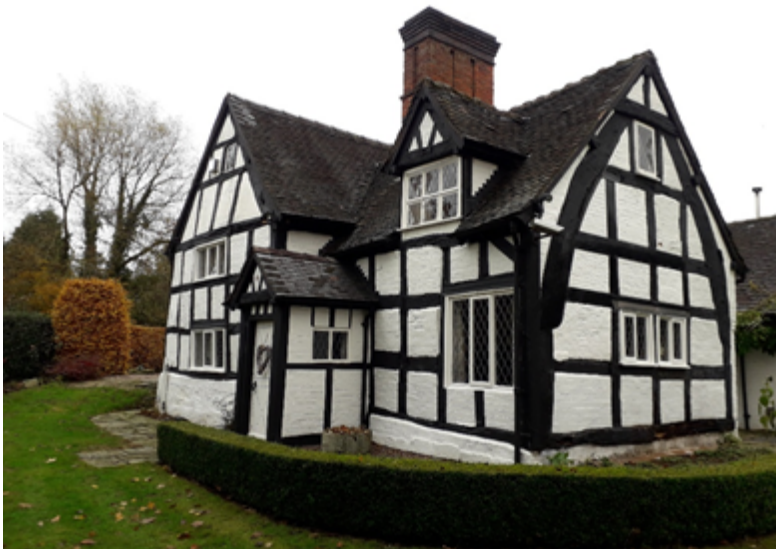
The Beehive (Grade II) is a cottage originally of cruck construction, probably 15th Century with 17th additions. The timber framing has painted brick infill panels. The Listing description states the building is of T-shaped plan with a single cell baffle-entry plan hall range with cruck frame aligned north-south. It also has a 17th century two bay crosswing on the north side, aligned east west. The cruck framing is largely complete.

This initial work included erection of scaffolding and careful investigation which has revealed severe structural problems within both of the gables. The south cruck gable, has problems which have originated because the soleplate has rotted, compressed and many

of the joints have failed and caused movement in the framing and panels have started to loosen. Previous work on this gable, prior to the current owners purchasing the property, have been poorly carried out by not fixing the new repairs into the oak frame with mortice and tenons creating an unstable frame. The west gable has also been investigated and the soleplate has also completely failed and requires complete replacement and vertical studs also require sections of timber to be spliced in. The tie beam at eaves level is of most concern as it appears completely rotten and is moving out taking with it the upper section of wall and the lower gable. This gable also requires tying back to the return walls. The brick panels are also moving out and need to be removed and re-laid. Careful shoring and propping is required during this repair so ensure the load is appropriately dealt with.
